Short communication

Upgrade of an automated line for plastic cap manufacture based on experimental vibration analysis

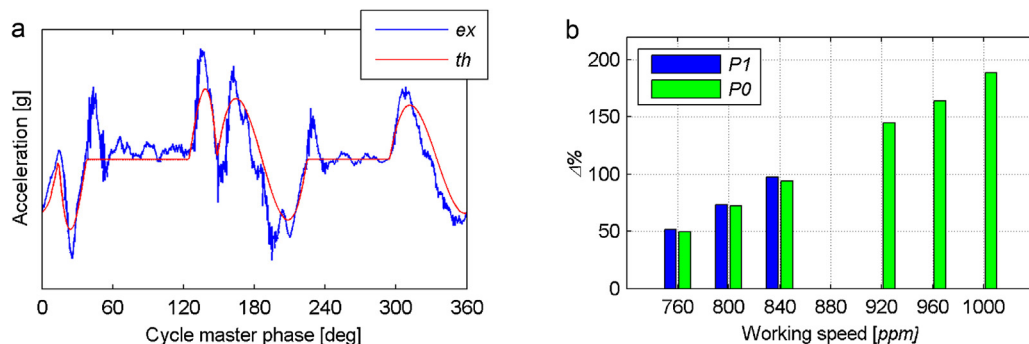
Fig. 3. (a) Experimental (*ex*) and theoretical (*th*) accelerations of the *P&P1* at 1000 *ppm* in condition *P0*, along direction X, over the machine cycle, and (b) index $\Delta\%$ relative to the same transducer for all tested velocities and conditions.

The *P&P1* exhibits values of $\Delta\%$ largely exceeding 150% for both the directions *X* (Fig. 3b) and *Y*, and even over 250% along the Z-axis, at the target velocity of 1000 *ppm* [2]. Such higher vibration levels may lead to the incorrect positioning of the *Comps* in the product trays, thus preventing them from being properly assembled and consequently causing the rejection of all 10 end products on the same tray. The severe vibrations predicted by the investigation may also entail considerable durability issues. Modifying the unit is therefore required. In practice, redesigning the *P&P1* end effector (a rather massive component in the current machine configuration) for reducing its moving inertia appears a feasible strategy for limiting vibration levels.

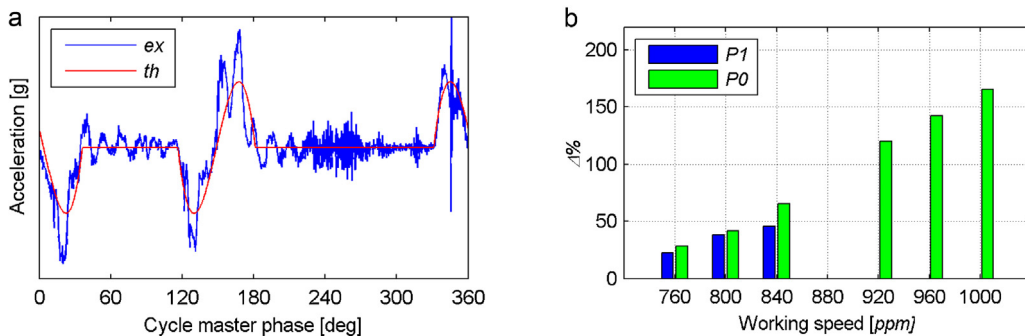
Severe vibrations characterize also the *OR*, along the Z-axis. The comparison between measured and theoretical accelerations along this direction, for operation at 1000 *ppm* in condition *P0*, is shown in Fig. 4a. The corresponding trend of $\Delta\%$ for conditions *P1* and *P0* over the tested working speeds is reported in Fig. 4b. Large oscillations of the *OR* end effector

Fig. 4. (a) Experimental (*ex*) and theoretical (*th*) accelerations of the *OR* at 1000 *ppm* in condition *P0*, along direction Z, over the machine cycle, and (b) index $\Delta\%$ relative to the same transducer for all tested velocities and conditions.

may determine incorrect orientation of the *Comps* (and subsequent assembly problems), therefore worsening the machine global performance, similarly to the *P&P1*. In addition, the significant increment in dynamic loads, entailed by vibrations, may raise the failure rate of the *OR* power transmission chain, in particular of its driving cam-rocker system [3]. Reducing the mass of the *OR* end effector is essential for addressing these issues.

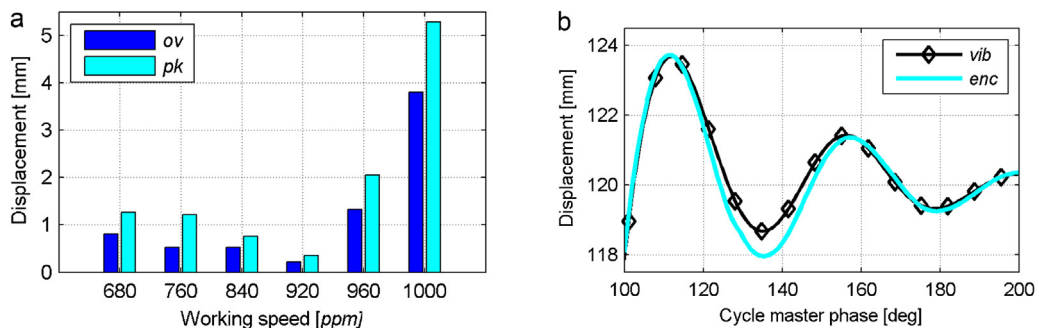
Fig. 5a reports the overshoot and peak-to-peak oscillation of the tray displacement for some tested velocities in condition *P0*. Neither quantity exhibits a monotonic growth with the increasing speed. Reasonably, some kind of antiresonant effect is present around 920 *ppm*, whereas operation at the highest velocities triggers one of the system natural frequencies (at about 14 Hz). Indeed large tray oscillations occur at 1000 *ppm*, which are not compatible with the correct machine functioning.

The vibrometer measurements and the data provided by the encoder monitoring the *TB* pulley are compared to find the source of the observed elastodynamic effects. The peripheral displacement of the toothed pulley is computed from the encoder signals by considering a pitch radius of about 114.6 mm (the pulley having 36 teeth and a 20 mm pitch). As an example, Fig. 5b shows a close up of the tray displacement and the *TB* pulley peripheral displacement around 120° of the cycle master phase, at 1000 *ppm*. The comparison clearly reveals that the tray displacement is almost completely ascribable to the *TB* compliance, whereas, contrary to initial assumptions, deformations occurring in the *MTU* belt conveyor are rather negligible (the tray on the *MTU* basically follows the *TB* pulley peripheral displacement). The same conclusion can be drawn for all tested velocities.

A new close inspection of the *TB* inside the machine detected the presence of extremely large belt deformations. Such deformations may cause the belt to jump teeth, thus leading to loss of synchronism between the *MTU* and the machine phase, and consequently to a critical failure. Furthermore, the excessive tray overshoot would rapidly damage the *Lock* and other auxiliary units. Reducing the *MTU* inertia and increasing the *TB* stiffness are both required for limiting oscillations.

Fig. 5. (a) Overshoot (*ov*) and peak-to-peak (*pk*) oscillation of the tray displacement as functions of the working speed; (b) comparison between tray displacement (*vib*) and pulley peripheral displacement (*enc*) at 1000 *ppm*.

In practice, the former strategy may be carried out by decreasing the mass of the product trays. The latter may be implemented by increasing the radius of both *TB* pulleys, as the belt equivalent torsional stiffness reduced to the *j-th* axis, K_{Tj}, is given by [4]:

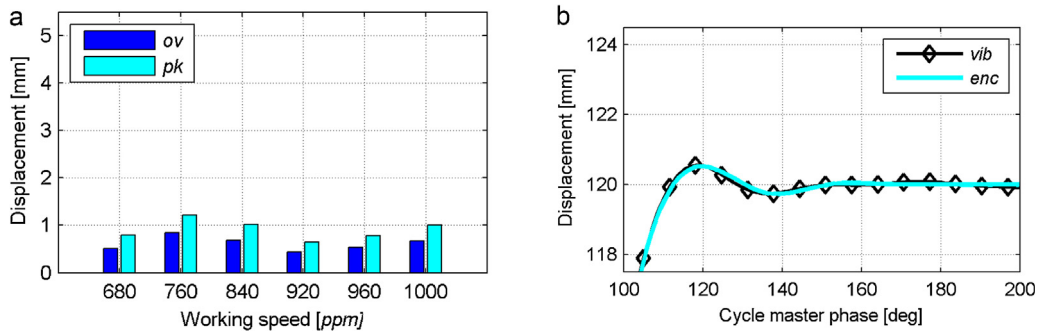
Fig. 6. Experimental results after *MTU* partial redesign: (a) overshoot (*ov*) and peak-to-peak (*pk*) oscillation of the tray displacements as functions of the working speed; (b) comparison between tray displacement (*vib*) and pulley peripheral displacement (*enc*) at 1000 *ppm*.

The tray displacements measured in these additional experiments are reported in Fig. 6. In particular Fig. 6a shows the overshoot and peak-to-peak values for all tested velocities, whereas the comparison between the tray displacement and the *TB* pulley peripheral displacement at 1000 *ppm* is reported in Fig. 6b. Vibrations appear significantly reduced. Therefore this single design modification is proven effective for mitigating the elastodynamic issues affecting the *MTU*.

A variant of the original machine was arranged and tested. It was obtained by implementing just one modification of the previous design, namely by replacing all the product trays of the *MTU* with lighter new ones. In particular, each product tray was redesigned by cutting down its mass by about 33%, thus significantly reducing the *MTU* total inertia. Indeed the original trays were found to be considerably oversized with respect to the minimum structural strength requirements.
